Memorandum

To: **City of Delta** Date: **April 16, 2026**

Reference: **Holly Elementary Pedestrian Safety Review** Project No.: **34583**

From: **Borg Chan, M.Sc., P.Eng., PTOE, RSP1 and Varsha Miriam Joseph, M.Eng., E.I.T.**

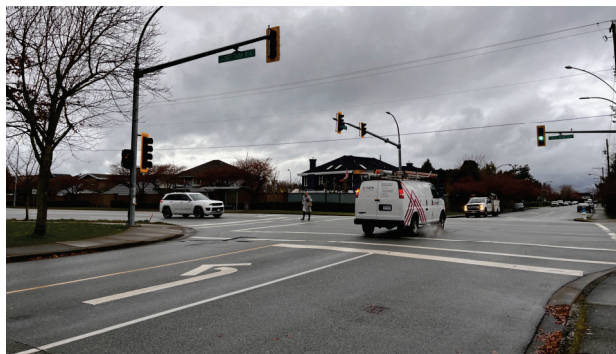
Northbound 62 Street at Ladner Trunk Road

Based on discussions with the school principal, no obvious road safety issues were identified and reported. On the other hand, the crossing guard noted safety concerns regarding vehicle speeding along Ladner Trunk Road and insufficient crossing times across the east and west legs at Ladner Trunk Road are noted during students travelling to and from the school.

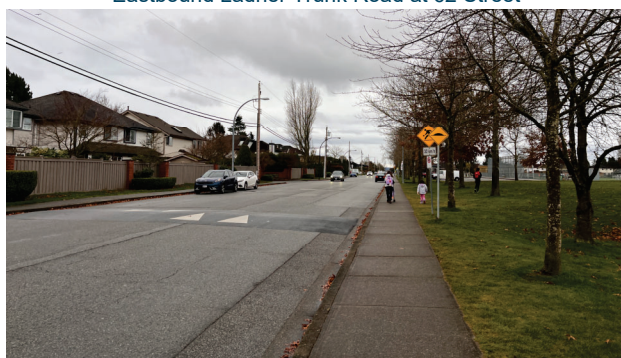
Speed hump along 62 Street (Facing southbound)

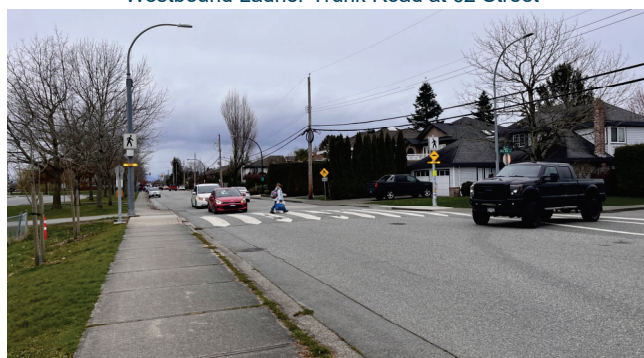
RRFB crossing at 62 Street and Holly Park Drive

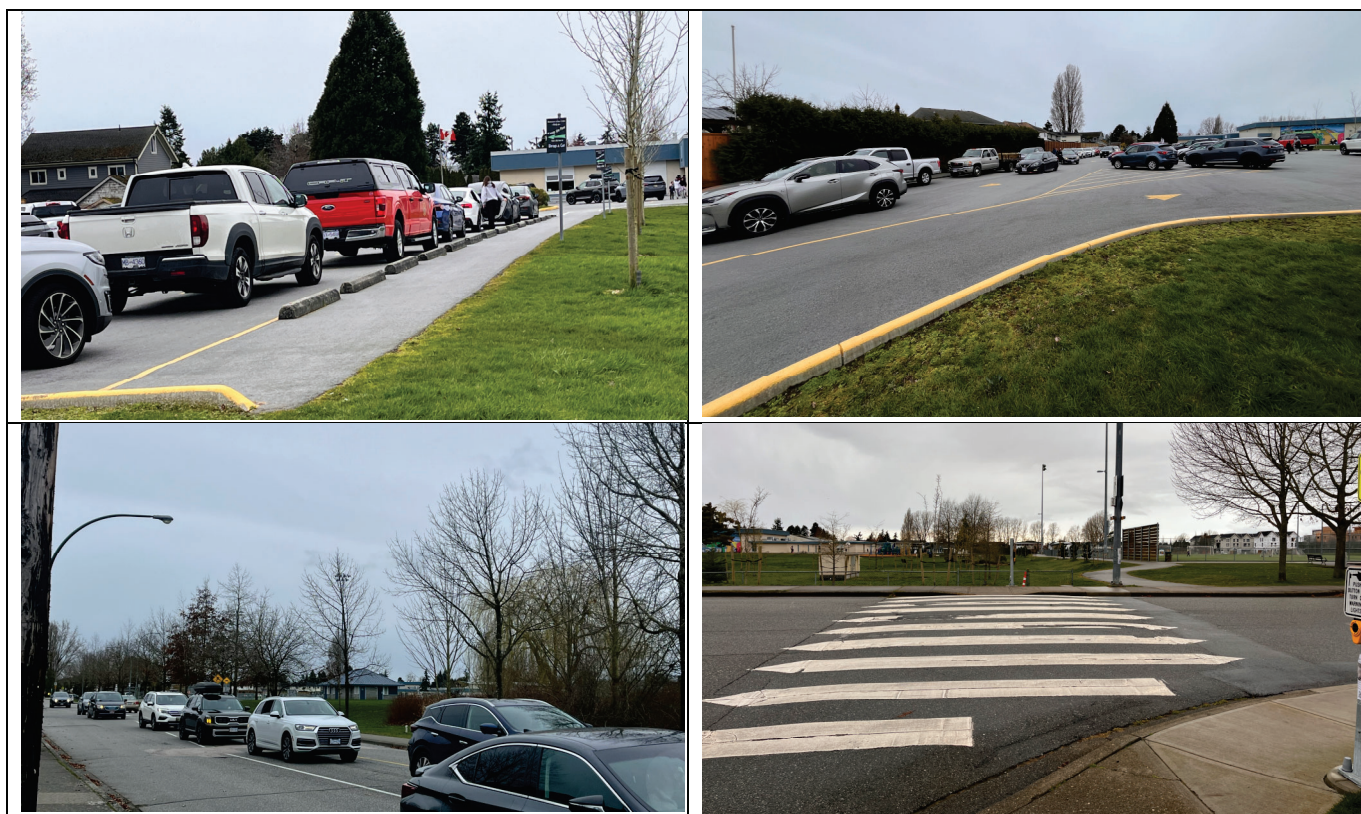
Figure 2.2 Field Review Photographs (Part 2)

- The student's pick-up and drop-off zone is located at dedicated area within the school premises, and no associated vehicles were noticed to park or stop along the City's roads. As a result, the potential traffic and pedestrian safety issues to the nearby road network are minimal.

- Overhead primary and secondary far-side signal heads were installed for all approaches with 300-millimetre lenses and yellow backboards as well as tertiary signal heads for Ladner Trunk Road; therefore, the driver's visibility to traffic signal should be adequate.

- Northbound left-turn queue at the intersection of 62 Street and Ladner Trunk Road exceeds the available storage length during the student's pick-up and drop-off times, resulting in queue spillback; however, they can usually be clear in one cycle.

- The pavement markings were clear during the daytime even with the cloudy and rainy conditions.
- Street lighting is provided at the four corners of the signalized intersection and along Ladner Trunk Road and 62 Street. Although no nighttime field review was conducted at this study, it is expected that the lighting conditions should be sufficient.

- The school pathway to 62 Street is not directly aligned with the marked crosswalk and the crosswalk pavement on the east side of 62 Street is located at the corner radius with Holly Park Drive, which may place pedestrians within the path of turning vehicles.

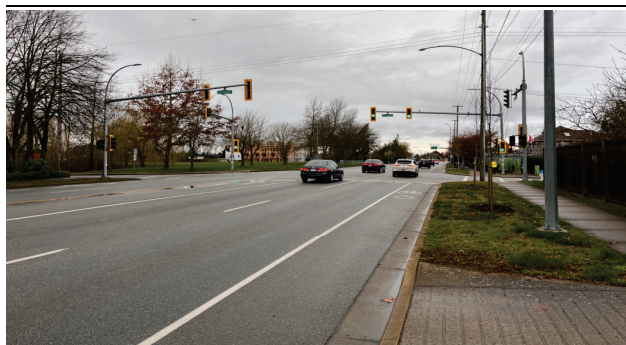
Vehicle Speeding

- The eastbound and westbound directions along Ladner Trunk Road exhibited similar average speeds (56 to 57 kilometres per hour – km/h) and 85th percentile speeds (64 km/h). Both surveyed speeds exceeded the posted speed limit of 50km/h.

- Higher operating speeds observed along Ladner Trunk Road could be influenced by its proximity to Highway 17A, west of 62 Street, creating a transition environment where drivers maintain faster speeds as they enter or exit the corridor.

As close to Highway 17A, elevated vehicle speeds were observed from both speed data and field review along Ladner Trunk Road (eastbound and westbound) and 62 Street. High operating speeds increase the risk of collisions, including:

- Rear end collisions
- Right-angle collisions
- Left-turn collisions
- Pedestrian and cyclists involved collisions

- **Install speed reader boards along Ladner Trunk Road**
Speed reader boards along both eastbound and westbound of Ladner Trunk Road would provide real-time speed feedback to drivers, encouraging compliance with the posted speed limit. Speed reader boards are effective traffic calming measures that can help reduce operating speeds, particularly near the school zones and with adult school crossing guards, thereby lowering the risk and severity of collisions.

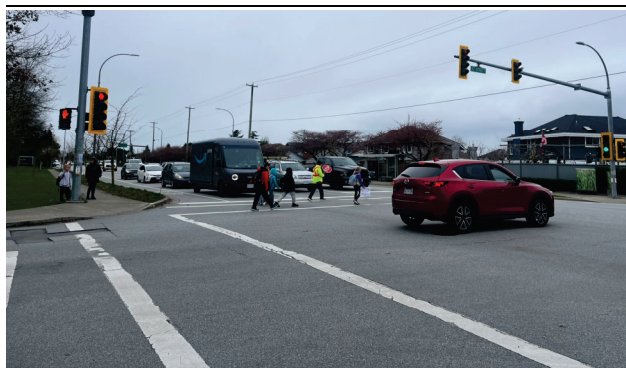
Constrained Pedestrian Clearance Time

For pedestrian crossing the east and west crosswalks (i.e., NB and SB movements), the pedestrian clearance time may be constrained and inadequate under both 1.2 m/s and 1.0 m/s walking speed assumptions. The pedestrian clearance time for crossing the north and south crosswalks (i.e., EB–WB movements) appears adequate when assuming a walking speed of 1.2 m/s. Under a more conservative walking speed of 1.0 m/s, an extension of approximately 1 to 2 seconds may be beneficial to account for children, seniors, and users with accessibility needs.

Based on Signal Timing Sheet review, it was found that pedestrian clearance time may be constrained, particularly when considering children, senior citizens, and users with accessibility needs, increasing the potential for

- Pedestrian involved collisions.

- **Review and extend pedestrian clearance time**
Based on the Signal Timing Sheet review in **Section 5.0**, extending the pedestrian clearance time may improve safety, particularly given the nearby school and the presence of children who may require more time to cross.

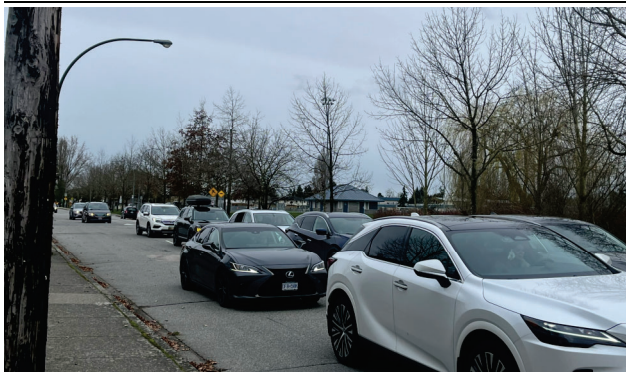
Northbound left-turn queuing exceeds storage space

During student's drop-off and pick-up periods, 62 Street northbound left-turn queue at Ladner Trunk Road exceeds the available storage length, resulting in queue spillback. This creates unexpected stopping conditions and limits available space for through traffic between left-turn queues and parked vehicles, increasing collision risks of:

- Side-swipe collisions
- Rear-end collisions

- **Extend northbound left storage length**
The northbound left-turn storage could be extended based on the maximum (95th percentile) observed queue lengths during student's pick-up and drop-off periods. This would help accommodate peak demand, reduce queue spillback into through lanes, and minimize the risk of rear-end and sideswipe collisions. This extension may result in the removal of few on-street parking spaces adjacent to the extension area.

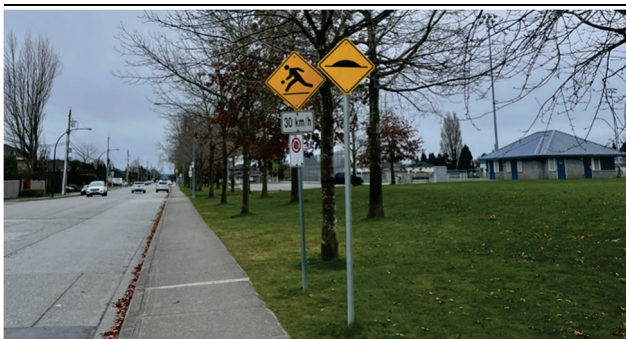
Signage placed too close to each other

The southbound "Speed Hump" and "Playground Zone" warning signs are placed in close proximity and do not meet MUTCD spacing guidelines. The placement may result in one sign obscuring the other, reducing driver awareness of the playground and school area and creating unexpected slow-down vehicles to check the sign. This could increase the risk of:

- Rear-end collisions
- Pedestrian involved collisions

- **Relocate the "Playground Zone" sign**
The "Playground Zone" sign could be shifted north to maintain a minimum spacing of 50 m from the "Speed Hump" warning sign, in accordance with MUTCD guidelines. This would improve sign visibility and ensure drivers can clearly recognize and respond to both warnings.
