Memorandum

To: **City of Delta** Date: **April 16, 2026**

Reference: **Holly Elementary Pedestrian Safety Review** Project No.: **34583**

From: **Borg Chan, M.Sc., P.Eng., PTOE, RSP1 and Varsha Miriam Joseph, M.Eng., E.I.T.**

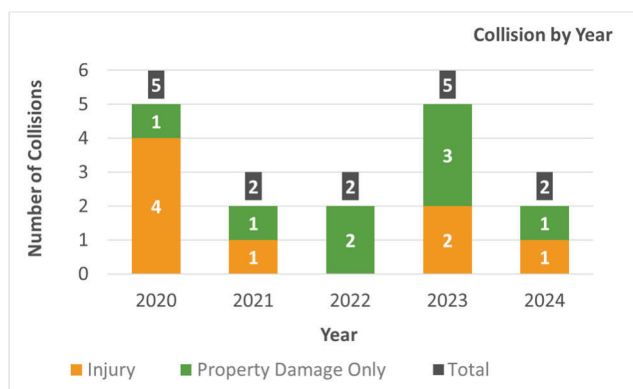
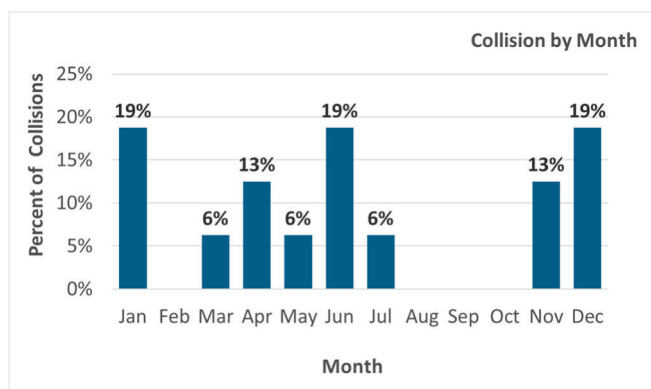
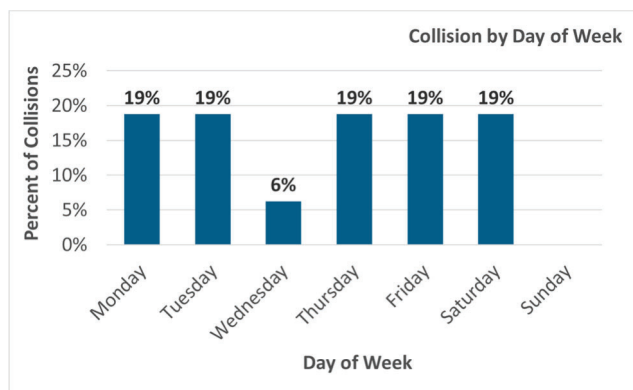
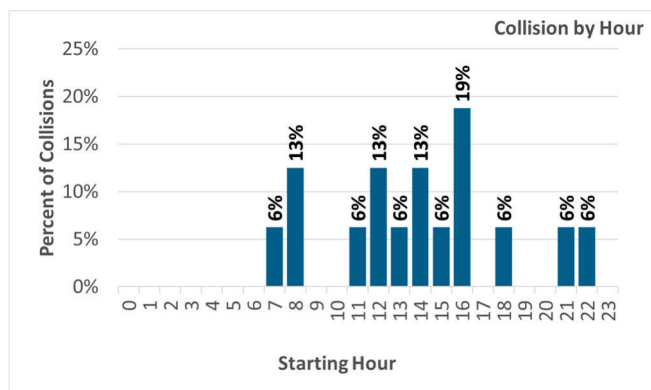
Figure 3.1 Temporal Distribution of Collisions at the intersection of Ladner Trunk Road and 62 Street

Yearly: The annual collision frequency averaged 3, with 2020 and 2023 both recording the highest numbers of collisions (5). In 2020, 4 of 5 reported collisions resulted in injuries – indicating a notable spike in both collision frequency and severity.

Monthly: Approximately 50% of all collisions occurred during the winter months (November to January). January, June, and December account for the highest monthly share (19%), while no collisions occurred in February and August to October.

Daily: On average, weekdays accounted for 16% of collisions per day, compared to 9% per day on weekends. No collisions occurred on Sundays.

Hourly: During students' pick-up and drop-off times between 7:00 and 9:00, and between 15:00 and 17:00, 19% and 25% of all collisions occurred, respectively.

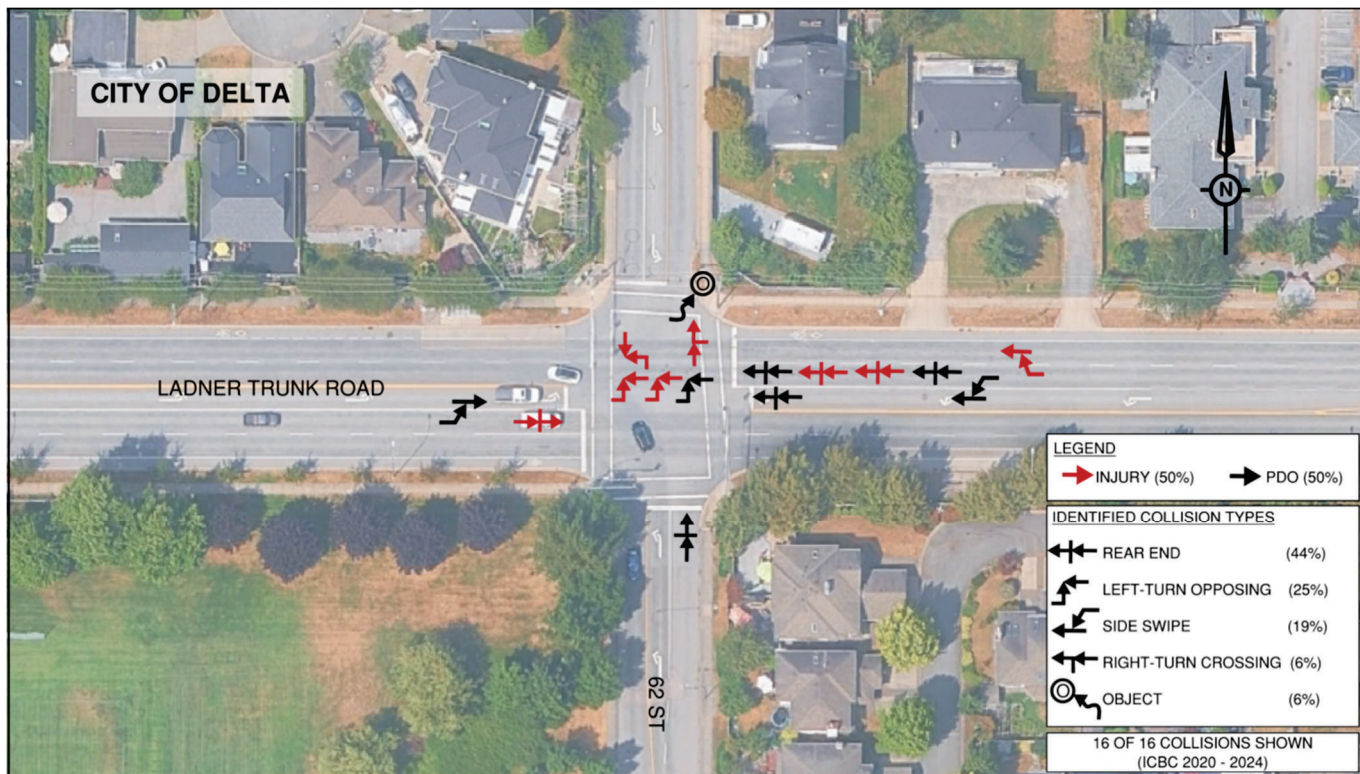
Table 3.1 Collision Diagram (ICBC, 2020-2024)

- **Rear-end collisions** accounted for 44% of all collisions (7 incidents), with approximately 43% of all rear-end collisions resulting in injuries. Five of the rear-end collisions occurred in the westbound direction, and one each in the eastbound and northbound directions. Contributing factors include vehicle speeding and distracted driving along Ladner Trunk Road.

- **Left-turn opposing collisions** were reported as the second most common type (25%), with 4 incidents with 75% resulted in injuries: 3 between eastbound left and westbound through movements, and 1 between northbound left and southbound through movements. Contributing factors include failure to stop at red light or yield to oncoming traffic.

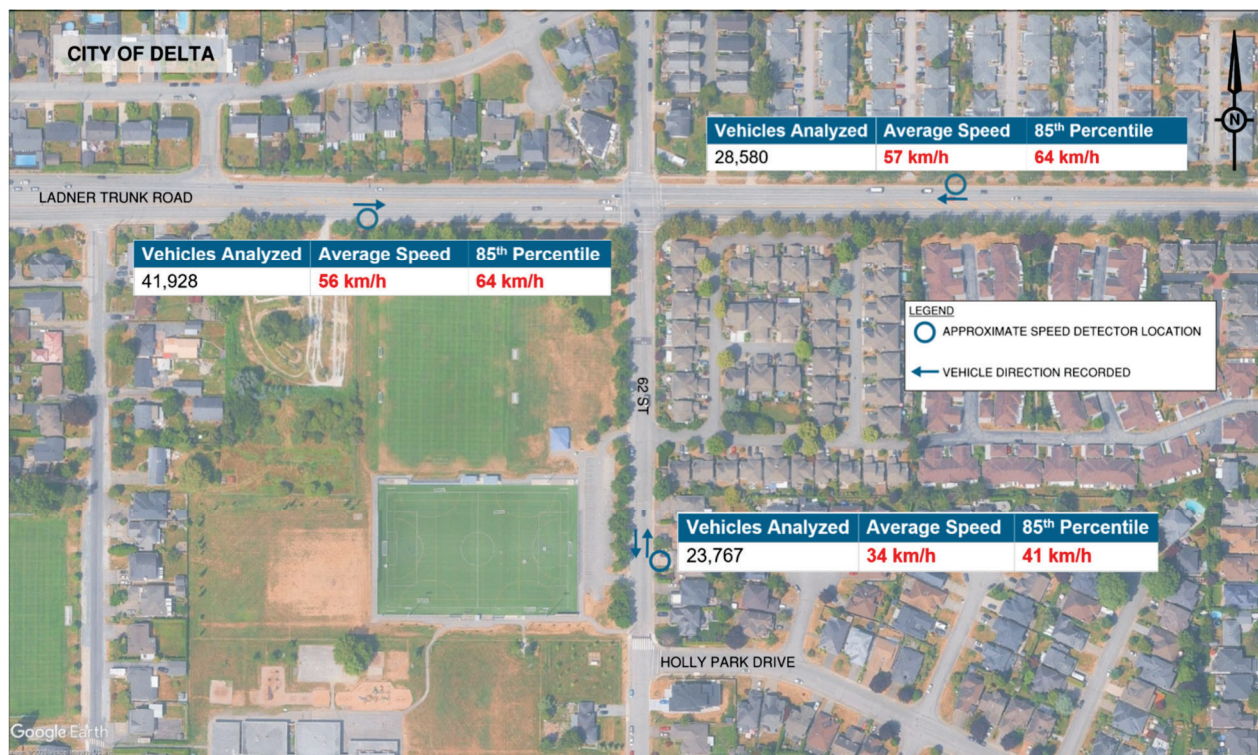
Figure 4.1 Traffic Volumes and Speed Data Review

The City provided surveyed traffic and speed data separately for eastbound and westbound movements along Ladner Trunk Road, and combined data for northbound and southbound movements along 62 Street, and was collected from February 18 to 27, 2026. **Figure 4.1** summarizes the traffic volumes and speed data review, including detector locations and information on total vehicles analyzed, average speed and 85th percentile speed for 10-day survey period. It is expected that higher vehicle operating speed increases the risk and severity of collisions.

- Higher operating speeds observed along Ladner Trunk Road could be influenced by its proximity to Highway 17A, west of 62 Street, creating a transition environment where drivers maintain faster speeds as they enter or exit the corridor.
